ANALYSIS TO KNOW CONTRIBUTING FACTORS FOR MILL CHATTERING PHENOMENON AND POSITION FOR DETECTING SENSOR IN 4-HI TANDEM ROLLING MILLS

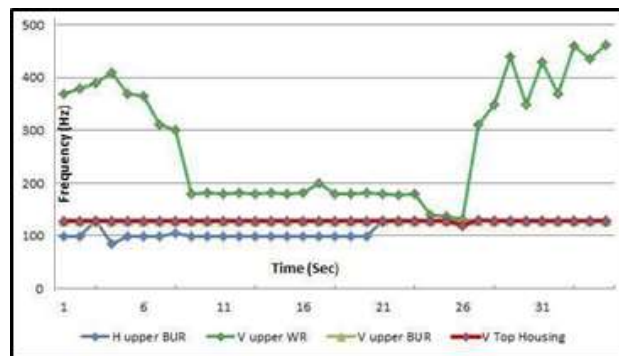
Figure 5: Variation of prominent frequency of the acceleration signals over time

In the first experiment, the 3rd octave chatter frequency closely matched the vibration frequency of the B/u roll and mill housing. The Acceleration Peak Time (APT) was at the 26th second. Horizontal vibration of the upper B/u roll was detected 5 seconds before APT, and the top work roll detected it 3 seconds before APT.

When chatter occurred (at the second 26 in Fig. 5), the mill operator promptly reduced the rolling speed to prevent strip rupture. However, this led to a temporary instability in the system due to the sudden decrease in rolling speed. Immediately after the speed reduction, a slight decrease in the chatter frequency from 141 Hz to 137 Hz was observed in Fig. 5 due to the changing rolling conditions. The

frequency of the 3rd octave chatter detected in this experiment was approximately equal to the vibration frequency of the backup roll.

From Figures 5 to 7, it can be concluded that the upper backup roll is highly sensitive to rolling chatter, and the top housing is relatively sensitive to chatter as well. Therefore, the upper backup roll and top housing are suitable positions for installing acceleration sensors to detect chatter.

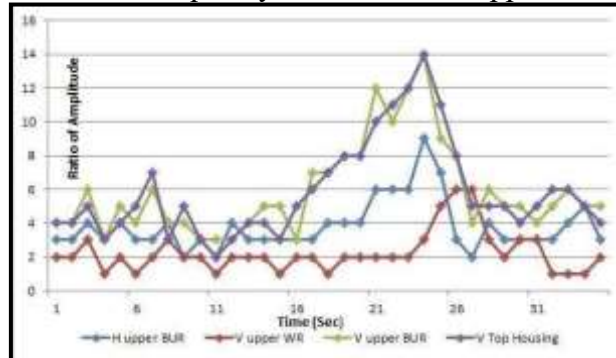
Figure 6 Ratio of amplitude of chatter frequency to RMS value of amplitude in frequency spectrum. The figure demonstrates that the amplitude ratio increases significantly when chatter occurs, varying between different signals. The signals for the vertical vibration of the upper backup roll and the vertical vibration of the top housing exhibit larger ratios. Another crucial observation from the figure is the time when the ratio starts to increase. The signals for the vertical vibration of the upper backup roll and the vertical vibration of the top housing show a shorter time before the Acceleration Peak Time (APT) when the ratio starts to rise. Hence, it can be concluded that these signals are more sensitive to rolling chatter.

Figure 6 demonstrates the ratio of the amplitude of the chatter frequency to the RMS value of the amplitude in the frequency spectrum over time for each signal. Prior to analyzing the acceleration signal, a low-pass filter with a cutoff frequency of 500 Hz was applied to the recorded data.

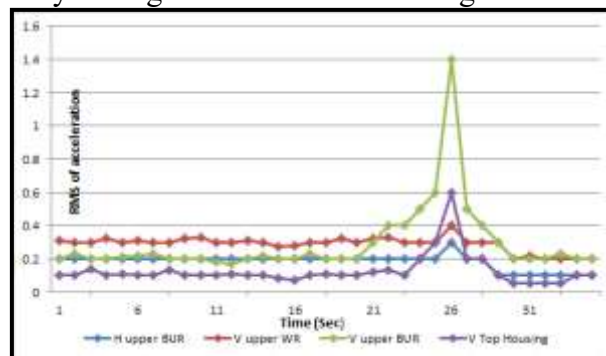
Figure 7 RMS value of acceleration signals

Fig. 21 illustrates the variation of the Root Mean Square (RMS) value of acceleration over time for each signal, with a low-pass filter applied at a cutoff frequency of 500 Hz to the recorded data. It shows the acceleration values during system stability and instability. At stability (before and after chatter occurrence), the upper work roll exhibits high amplitude vibration, with a small increase during chatter. The upper backup roll vibrates less than the upper work roll when the system is stable but experiences severe vibration during chatter, particularly in the vertical direction. The top housing exhibits slow vibration at the time of stability but significant vibration during chatter.

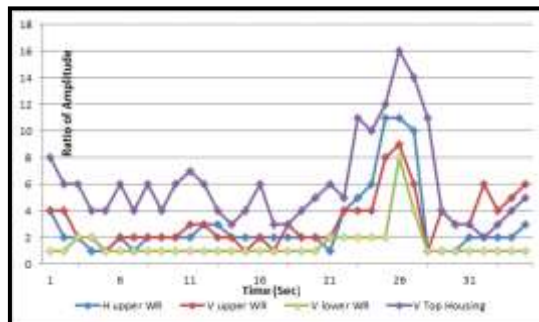
Figure 11 Ratio of amplitude of chatter frequency to RMS value of amplitude in frequency spectrum

Fig. 11 presents the amplitude ratio of the chatter frequency to the RMS value of the amplitude in the frequency spectrum over time for each signal, following a low-pass filter application with a cutoff frequency of 500 Hz. The 26th second corresponds to the APT. The signal for the vertical vibration of the top housing shows the largest ratio at APT, indicating that the top housing is highly sensitive to rolling chatter.

Based on Figures 10 to 12, it can be concluded that the top housing is more sensitive to chatter compared to the work rolls. Considering the results of both experiments, the upper backup roll and top housing demonstrate high sensitivity to chatter, making them suitable positions for installing permanent acceleration sensors to detect chatter.
