EVALUATION OF THE STRENGTHENING EFFECT ASSESSMENT OF A DETERIORATED BRIDGE VIA TESTING VIA THE EXTERNAL PRE-STRESSING METHODOLOGY

Keywords: strengthening method; strengthening effect; external pre-stressing; deteriorated bridge.

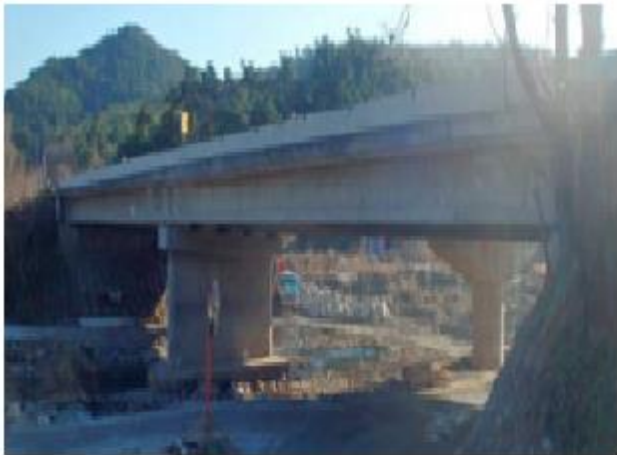
Figure 1. Front view of the deteriorated bridge (unit: mm).

As demonstrated in The bridge used in the experiment was built in 1975 and removed after about 45 years of usage. The bridge is a two-span continuous PSC girder with specifications of 60.9 m in length, 30.5 m maximum span, and 11.7 m in width. However, the lack of design data is mostly owing to the extended service duration. Furthermore, the design drawing's poor resolution hinders the precise inspection of requirements. The parameters of the bridge were checked by measuring. Figure 2 displays the bridge's cross-section. The girder's compressive strength is 27 MPa. Tendons with a diameter of 8 mm and tensile strength of 1560 MPa were placed into seven ducts using 12 strands, based on the current engineering information.

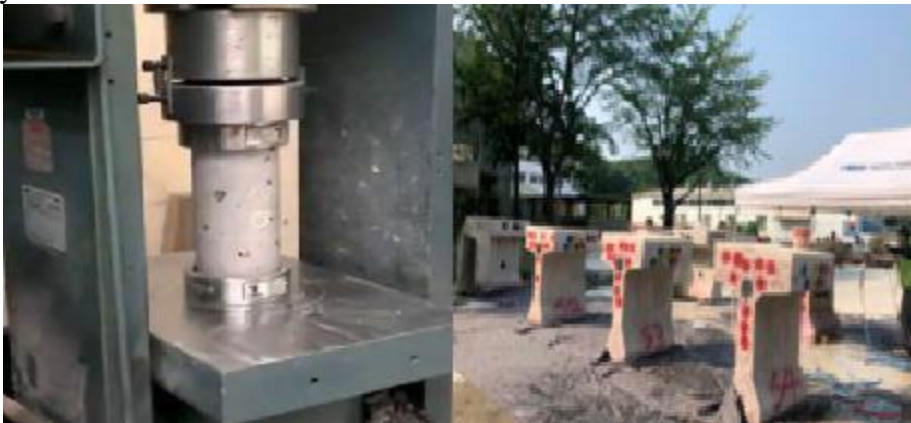
Figure 3. Core sampling

Materials properties testing were carried out on the concrete and tendons of the degraded bridge to determine the material qualities of the bridge. Approximately 50 cores were taken from different locations of the girder, as seen in Figure 3, and subjected to a compressive strength test. The test showed that the concrete compressive strength was 33 MPa, which was 22% greater than the starting strength of 27 MPa. It was unable to ascertain whether the strength was changed since there was no value for experimentation available during its manufacture. A tensile strength test was conducted on five tendons taken from the specified bridge. The test revealed a tensile strength of 1660 MPa, indicating a 6% increase compared to the original design data of 1560 MPa. Thus, it may be inferred that there was no notable impact on the performance of the tendons inside the grout, even after 45 years.

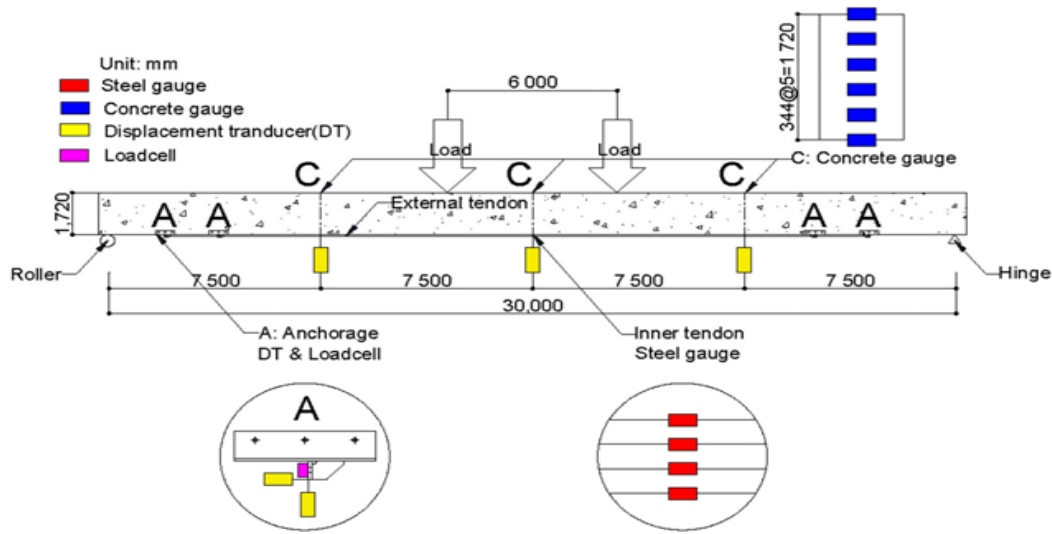
Figure 5 Experimental setting.

The investigation was conducted in three parts. An assessment was undertaken to evaluate the performance of the existing bridge before strengthening the destroyed bridge. The second phase involves using the external pre-stressing approach to reinforce the structure using external tendons. After reinforcement, a loading test was conducted to confirm the performance. Figures 5 and 6 show the use of two actuators with a capacity of 5000 kN. A four-point loading test was conducted for safety purposes using a displacement control technique at a speed of 2 mm/min. The boundary condition for the beam was established with a hinge and roller located 250 mm from both ends. The load was adjusted to create a pure bending section with a length of 6 m and a breadth of 3 m on each side from the centre of the specimen. In the pre-strength phase, the force was applied until the fracture appeared, whereas in the post-strength phase, the weight was applied until the structure was torn apart.

A leaflet-type anchoring with placed anchor bolts was used to sustain all loads. Two strands were dispersed and fastened for anchorage performance, as seen in Figure 5.

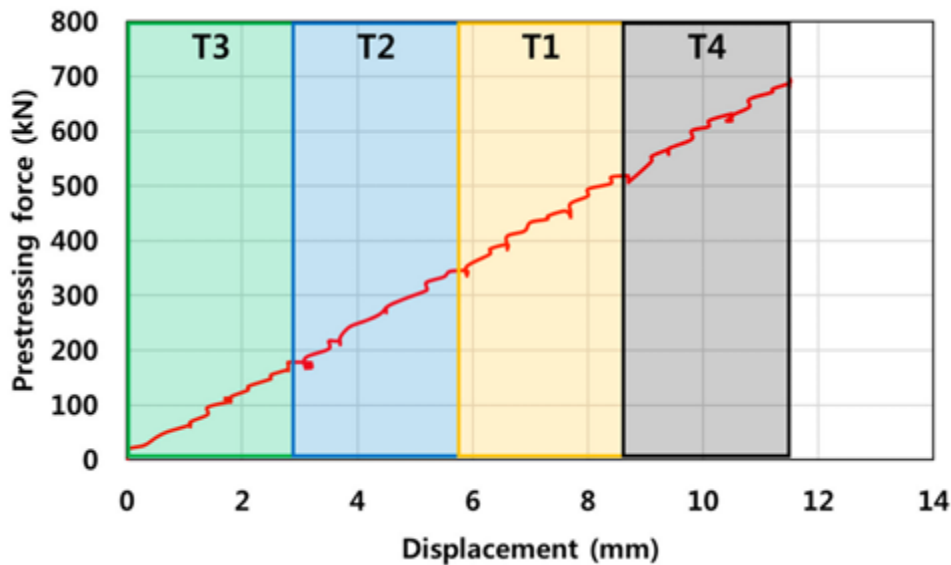
Figure 7. Displacement according to pre-stressing

The injected tension was decreased as a result of the slip produced during connecting the tendon to the fastening device and the loss of elasticity caused by the following tension in the tendon. The anchorage's activity increased by 0.06 mm when the tension force was supplied to the individual tendon, demonstrating that the anchoring provided sufficient safety against the imposed tension. At the midpoint of the span, a vertical movement of 11.5 mm (upward) occurred once all pre-stressing forces were activated. Figure 7 illustrates the girder's displacement caused by the exterior tendons' pre-stressing.

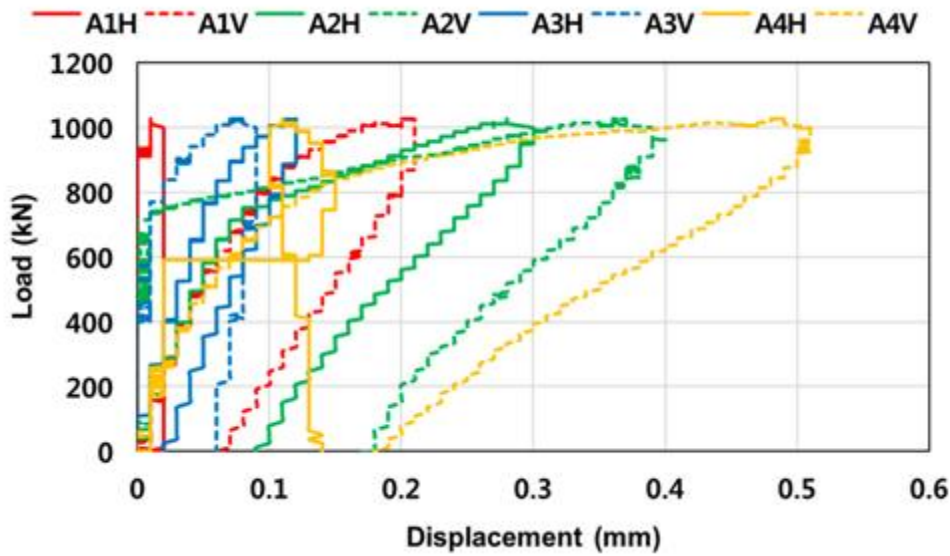
Figure 8. Anchorage displacement.

In Figure 8, you can see the way the mooring moved. Where "number" is the tendon number, "H" is the horizontal displacement, and "V" is the vertical displacement. As shown in Figure 8, the biggest movement that happened was 0.5 mm, and the grounding stayed safe even when the load went up.

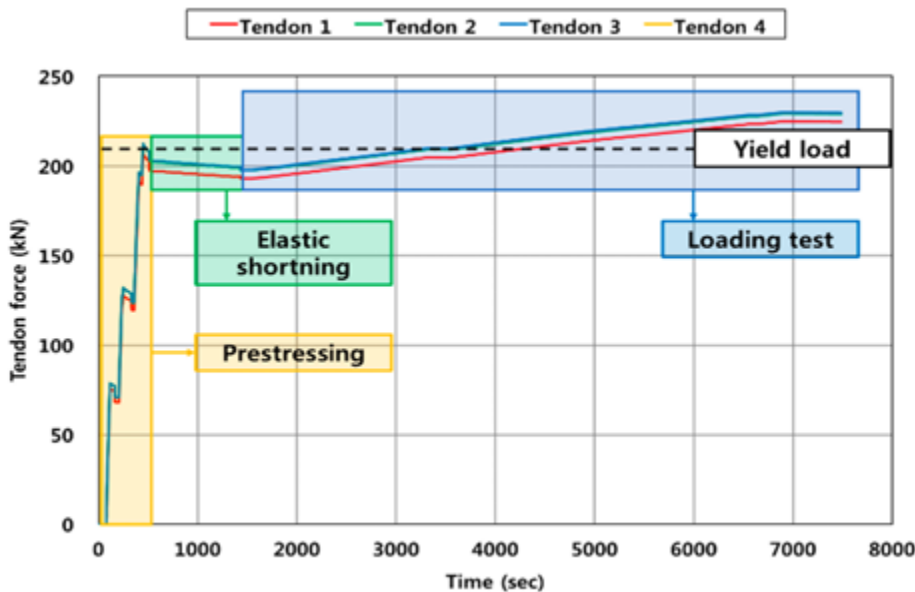
Figure 9. External tendon force.

As the load goes up, Figure 9 shows how the stress on the external muscle changes. The exterior tendon has a width of 15.2 mm, a surface area of 138.7 mm², a yield load of 222 kN, and a tension load of 261 kN. According to the test data, the yield was proven at around 210 kN, and the external tendon broke at around 230 kN. This is not the same as the supposed mechanical qualities, and it is thought to be a mistake in the experiment because the loadcell wasn't lined up with the muscle when it was put in place.

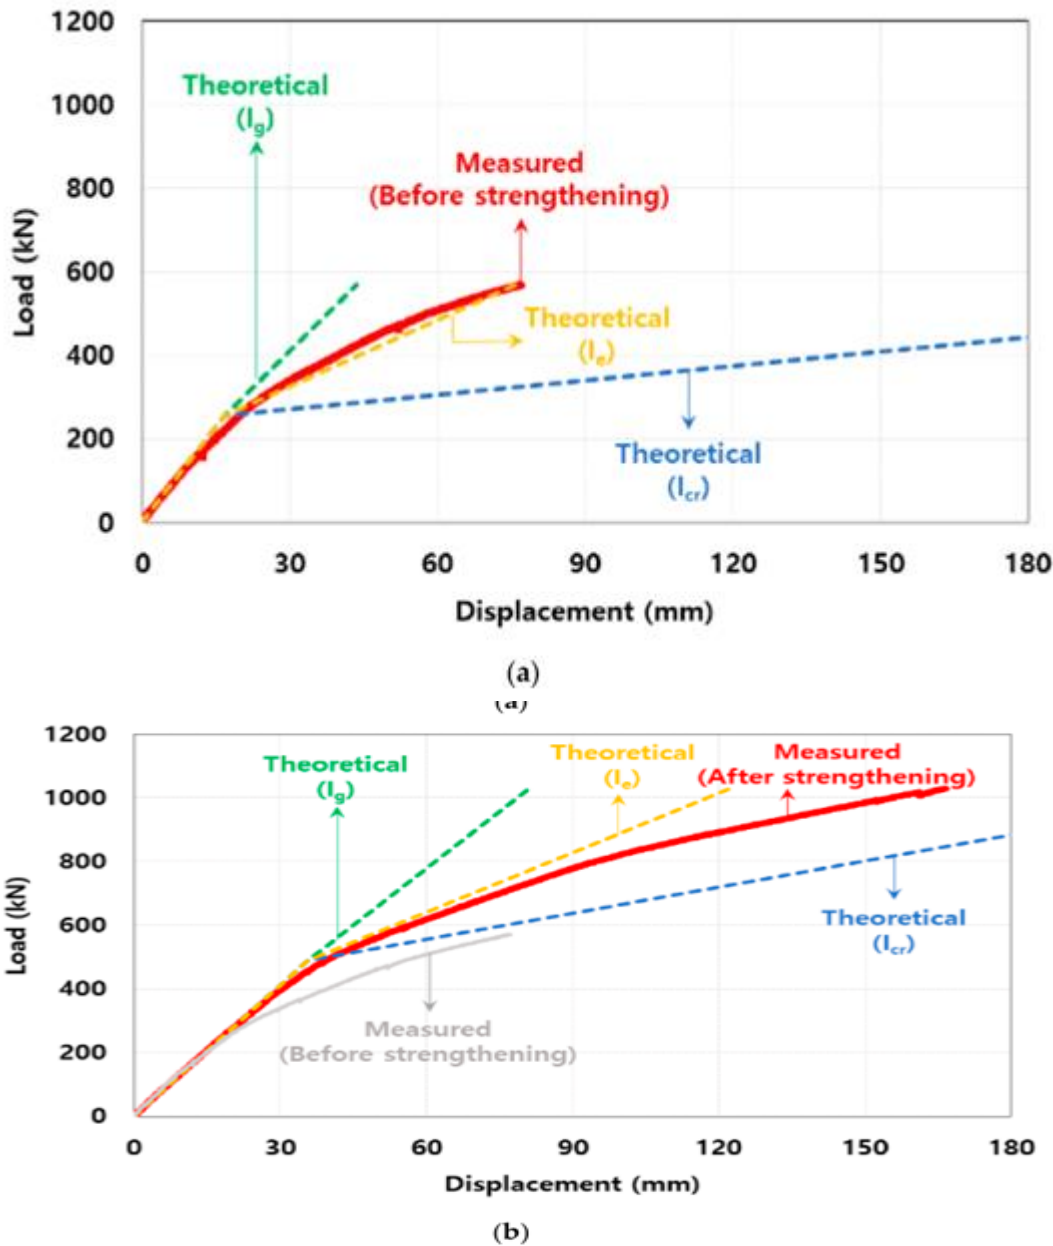
Figure 10. Load-displacement relationship: (a) Before strengthening; (b) After strengthening. While a crack appears on the surface of concrete, the connected strain gauge quickly records a wide range of values. We can't trust the number that was measured after the crack appeared. Following this, to see the differences in behaviour between before and after strengthening, the deflection evaluation result, which shows the overall behaviour, and the strain gauge attached by exposing the internal tendon after crushing the concrete surface were used to compare the two. The cross-sectional second moment analysis method was used to look at the actual results, as shown in Equation (1) [35]. For this, the load–displacement relationship of the cracked part is broken down into two straight lines with slopes of I_g and I_{cr} . When the effective cross-sectional second moment was used instead of the simpler formula, I_e was closer to the number found in the examination.

In Figure 10, you can see how the girder's load and movement changed before and after it was strengthened. Before it was strengthened, the beam was loaded with only 570 kN. The beam was loaded with 1028 kN based on how far along the bending crack it was after being strengthened with all external tendons jacked. After being strengthened, the trial stopped when the external tendon failed, not when the anchoring fell out. The anchorage did not come loose or crack until the experiment was over. This suggests that the tensile strength of the strands was good enough if the connection was designed.

This was proven that the slope of the load–displacement relationship changed at about 240 kN before strengthening and at about 470 kN after strengthening. This caused the concrete to crack and the crack load to rise by about 50%. But, as you can see in Figure 10b, the curve of the link between the pre-crack stress and movement before and after strengthening was the same. Because of this, the stiffness stayed the same, making it hard to see if the strengthening worked by comparing the stiffness before and after. As a result, it is hard to figure out the crack load in a real bridge through an experiment. This means that it would be hard to prove the strengthening effect before the bridge cracked. Also, if you look at Table 4, you can see that the amount of displacement caused by the same load goes down after stiffening. When the force was 400 kN, the bending before strengthening was 39.7 mm. After strengthening, it was 30.3 mm, showing that the effect of strengthening was about 23.7%. Also, at 470 kN, the deflections before and after strengthening were 51.7 mm and 37.2 mm, respectively, and the strengthening effect was found to be 28%. It was also found that the strengthening effect grew as the load did. In the last step of loading, the beam bent 77.1 mm before and after strengthening, and it bent 51.3 mm after strengthening, showing that the effect was 33% stronger. So, with an external prestressing of 180 kN for four tendons, the bridge used in this trial that was in bad shape was able to hold about 33% more weight. Figure 11 shows the relationship between load and strain in the internal muscles before and after they were strengthened. It was hard to tell if the reinforcement worked because the slope was the same before and after the reinforcement. This was because the load–strain relationship of the internal muscles was similar to the load–displacement relationship. However, the strengthening effect shown in Table 4 through the load-displacement relationship and the strengthening effect shown in Table 5 through the load-strain relationship were not exactly the same. Before it got stronger, the internal tendon was under 555 kN of stress. A strain of 366 was created after strengthening, proving a reinforcement effect of about 34.1%. Also, the strains were 741 before and 452 after strengthening at 470kN, which is the stress level where cracks appear. This means that the strengthening effect was 39%.

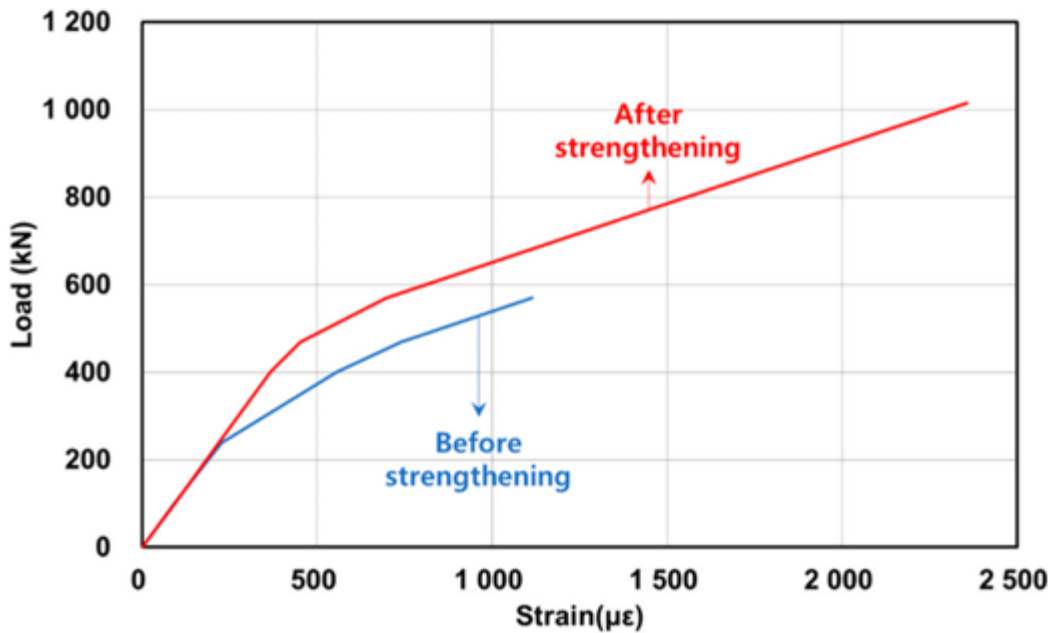
Figure 11. Load–strain relationship.
